AFML-TR-66-310
PART V
VOLUME III

The work presented in this volume is concerned with the performance prediction, testing, and post-test evaluation of a representative graphite-fiber, resin-matrix aircraft fuselage component. Additional material properties were determined and structural margins of safety defined by discrete element analysis. After seven response tests under various load combinations, the component was tested to destruction under combined bending and shear loads. Failure occurred at 110 percent of the target design load but below the failure load predicted from tests on flat panels. A weight saving of 27 percent over an aluminum structure of equivalent strength was demonstrated. The component was also three times stiffer than an aluminum structure of the same weight. Performance projections indicate that the same component built with presently available "Thornel" 50S fibers would offer a weight saving of 49 percent. Post-test evaluations included tensile and compression tests on curved skin panels, on stringers, and on stringer-skin combinations. Optical and electron microscopic examination of the fracture surfaces provided further insight into the failure mechanism

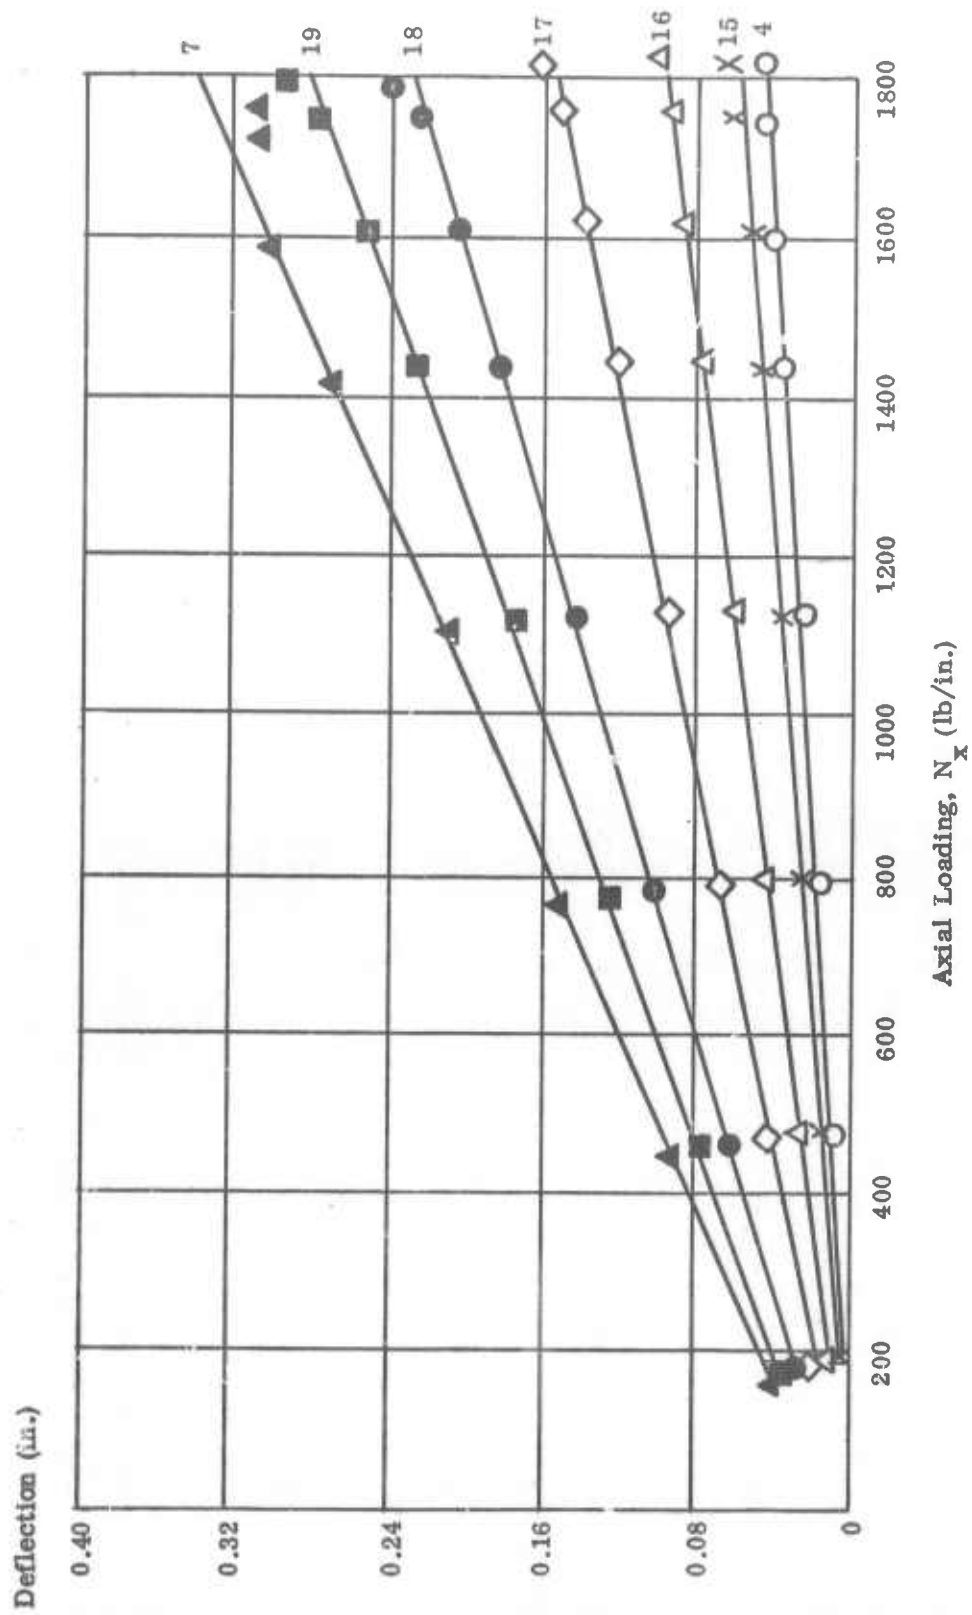
Figure 21(a). Deflections versus Load at Bottom of Structure from Destruct Test

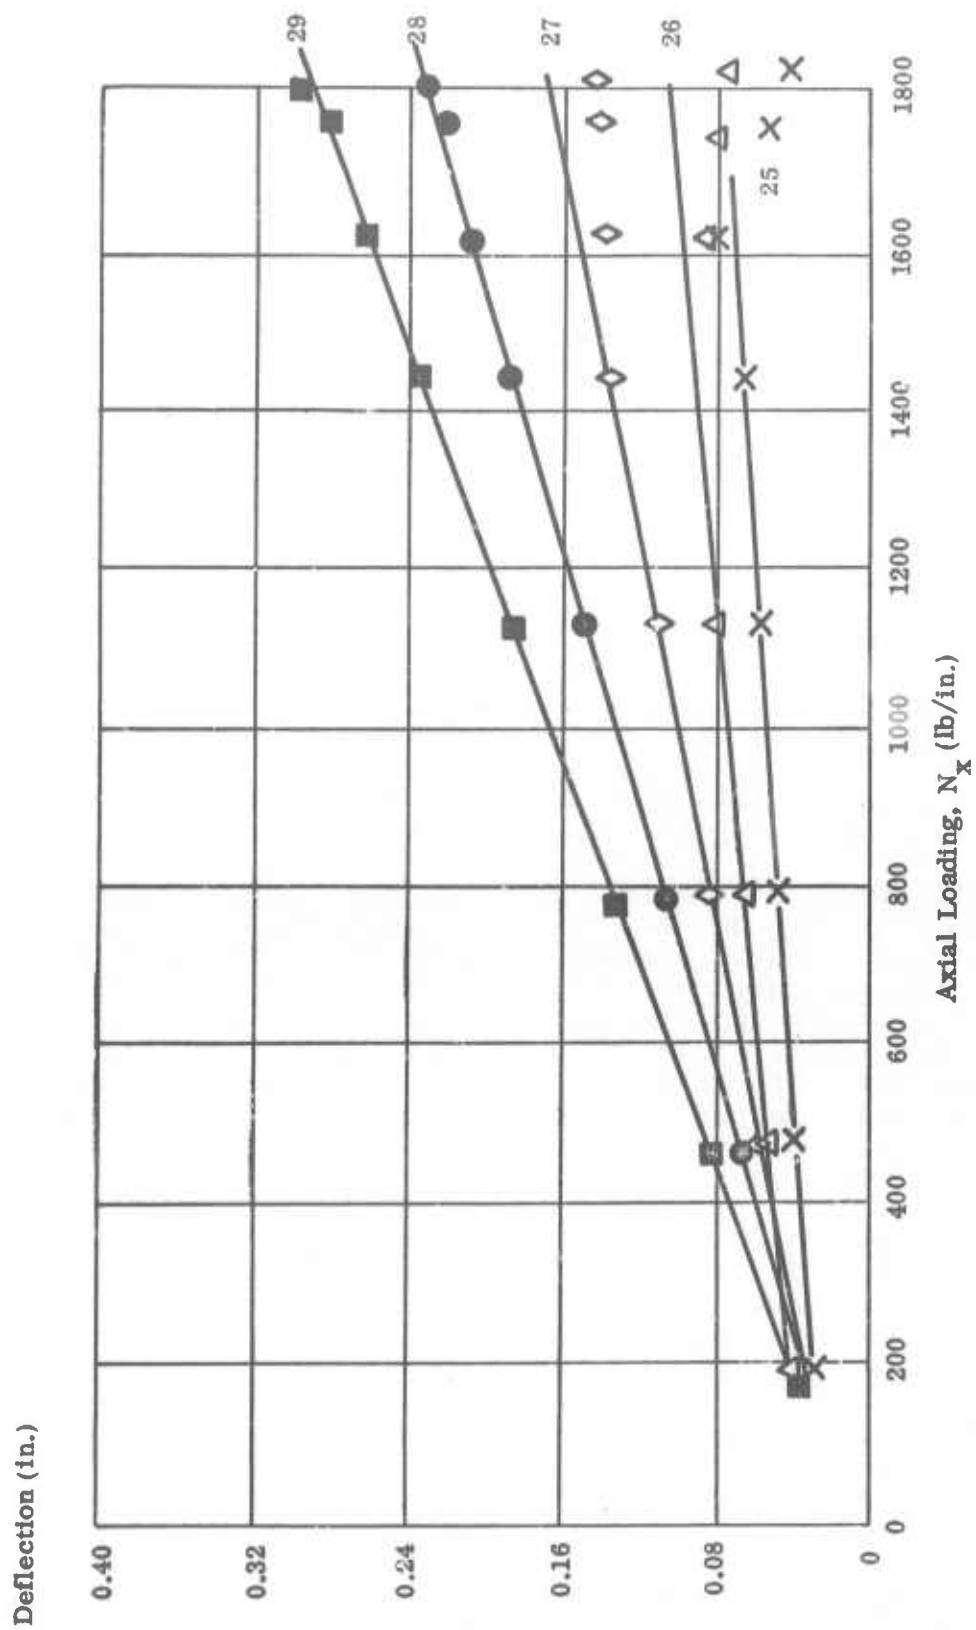
Figure 21(b). Deflections versus Load at Top of Structure from Destruct Test

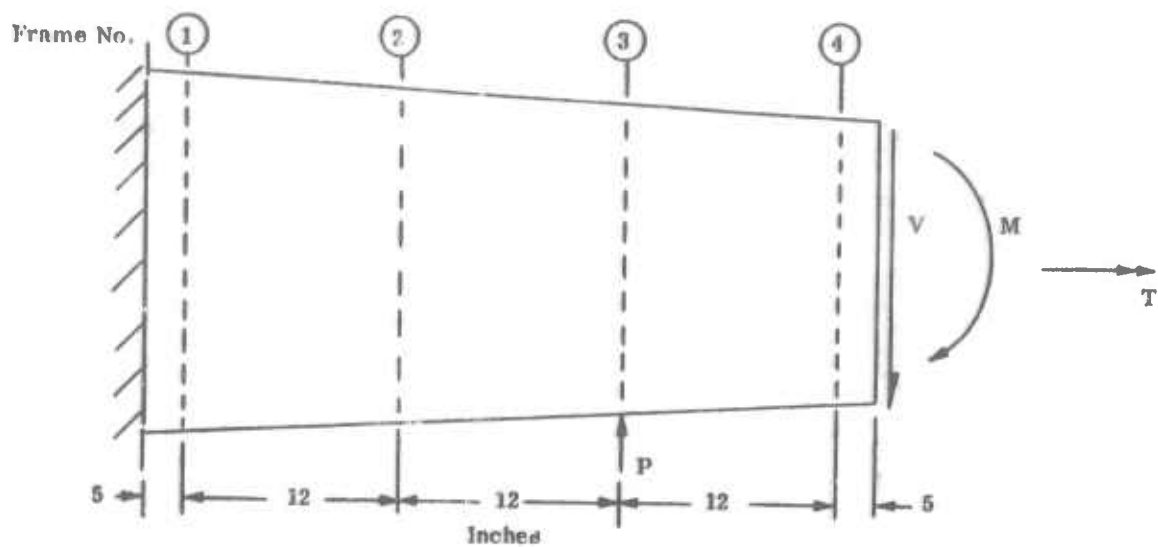
Load Cond	M (in. lb)	V (lb)	T (in. lb)	P (lb)
Nominal Analysis				
1		7,350		
2	576,000			
3			114,600	
4				80
Test Analysis (Current) *				
1	308,000	2,080		
2			42,600	
3	135,000		28,200	
4				
5	631,000	13,400		80

Figure 22. Summary of Load Conditions - Nominal and Current Analyses

Preliminary analysis of the fuselage structure utilized nominal shell geometry, computed material properties, and arbitrary but representative load conditions (Section III B of Reference 6). Further analyses have been conducted by using better defined material properties and thicknesses as given in the previous report section along with better defined loading conditions for the test program. The structural idealization is the same as that described in Section III B of Reference 6. Four loading conditions were analyzed in the "Nominal Analysis" (6) and five loads were considered in the "Current Analysis" as summarized in Figure 22.

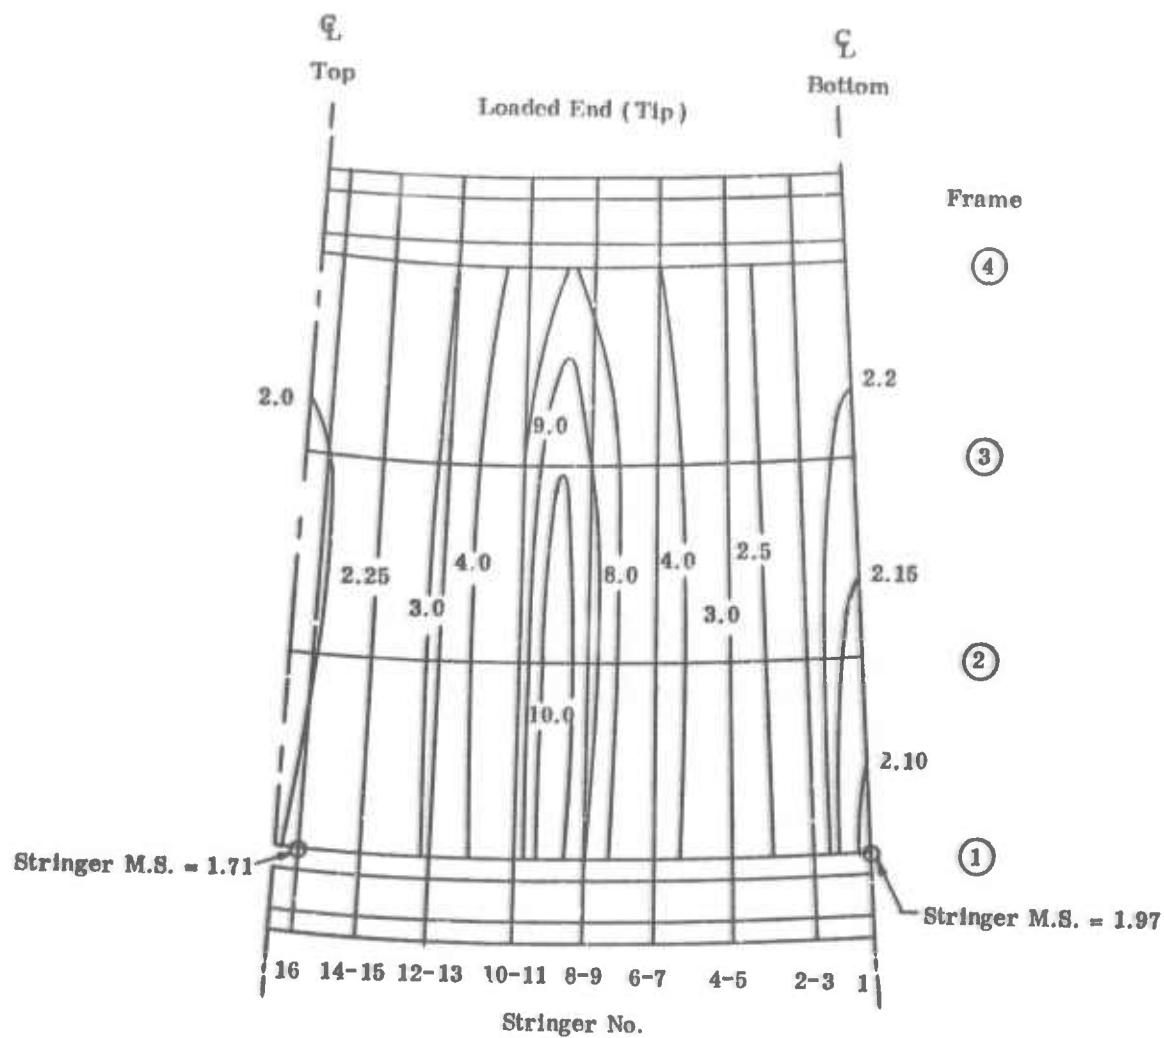
Figure 23. Margin of Safety Distribution (Developed Shell) Load Condition 1 - Moment and Shear

Figure 23 presents a contour plot on the developed shell of the computed skin margins of safety. Similar contour plots from the earlier (nominal) analysis for Load Condition 1 (shear only) and Load Condition 2 (moment only) were given in Figures 5 and 9 of Reference 6. L.C. 1* is seen to represent primarily bending. However, comparison with previous results (Reference 6, Figures 5 and 9), shows that the influence of shear is significant. The influence of bending due to shear in L.C. 1 is sufficient to reverse the contour pattern generated by bending stresses in the top and bottom regions of the structure. In the case of Figure 9, (6), the taper in the structure caused

In looking at the side panel elements of Figure 23, which are governed by shear stresses, comparison of the current case with L.C. 1 of the earlier analysis (Figure 5 of Reference 6) is of value. Here the influence of the shear load appears in the half-loop between stringers 8-9 and 10-11 of Figure 23 (as opposed to the virtual absence of such loops in the bending only case of Figure 5 in Reference 6). Direction of the loops is, however, reversed due to effects of the applied bending moment. It is also noted that distortion of the loops as shown in Figure 9 of Reference 6, caused by the relatively large difference between tension and compression allowables, is greatly reduced in the present case. Despite the apparently large changes in the M.S.* pattern in the region governed by shear stresses, it is noted that the minimum M.S., though large in this case, still occurs at the loaded end (tip).

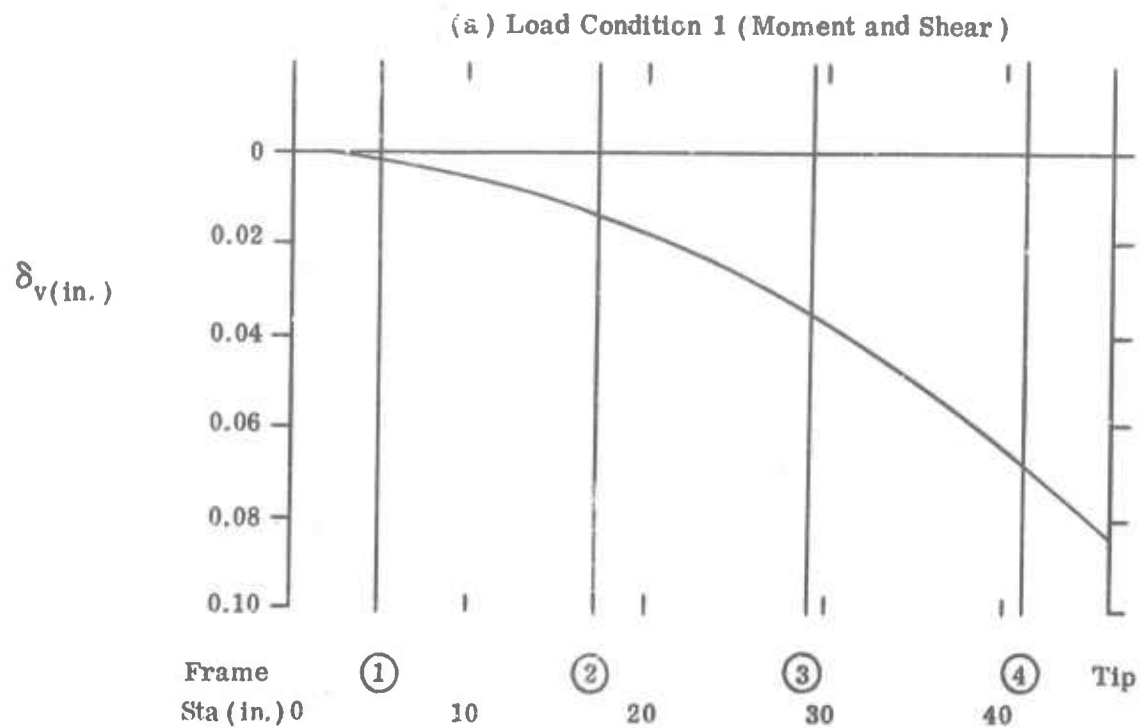
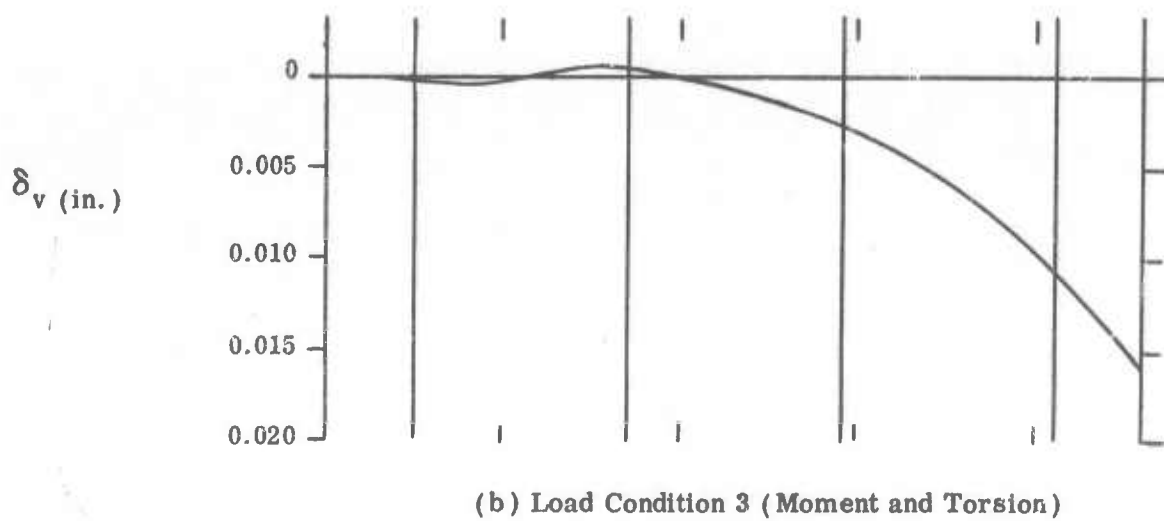
Figure 24. Vertical Displacements of Fuselage Shell - Loading Conditions 1 and 3

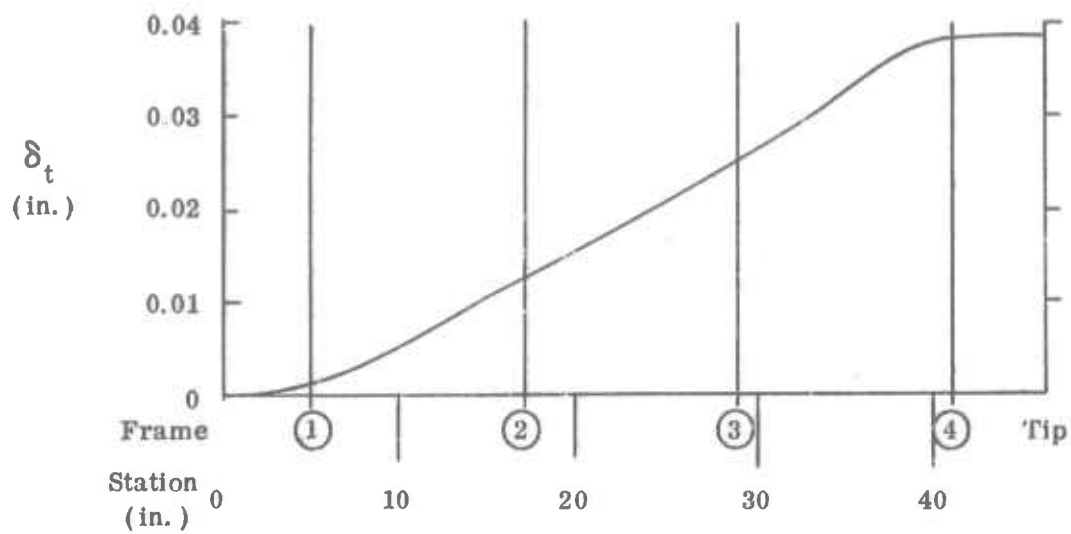
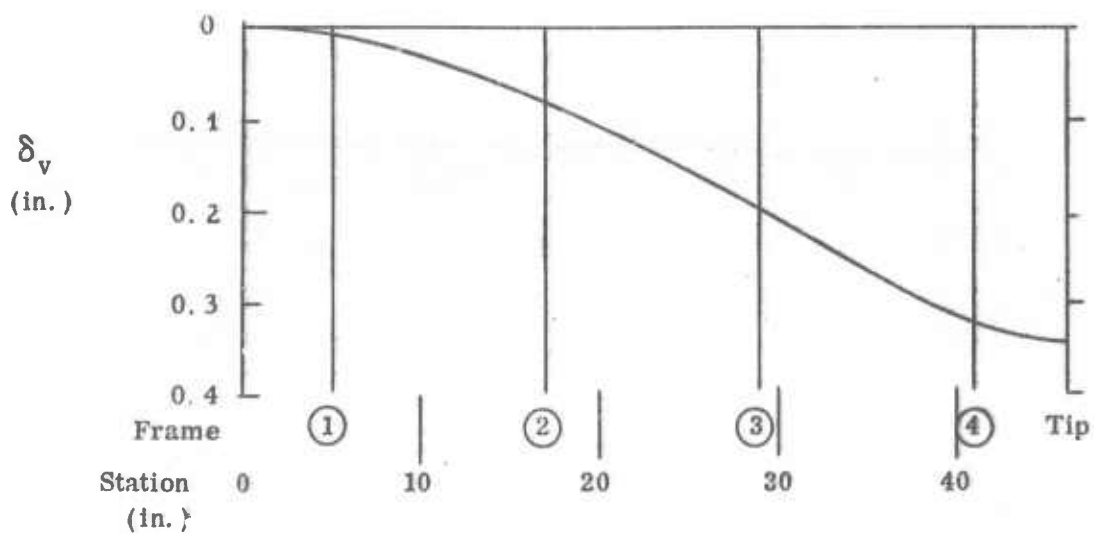
(a) Tangential Displacement of Stringer 1 (Bottom) for Load Condition 2 (Torsion)

(b) Radial Displacement of Stringer 1 (Bottom) for Load Condition 5 (Moment and Shear - Ult.)

Figure 25. Displacements of Fuselage Shell - Loading Conditions 2 and 5

L.C. 2 reiterates the situation established for L.C. 3 of the nominal analysis where the loading condition was identical though of different magnitude. Once again the M.S. contours show curves parallel to the ring frames with values ranging from 7.25 at Frame 1 to 5.3 at Frame 4. Figure 25 (a) shows the tangential displacement of the shell for this load condition.

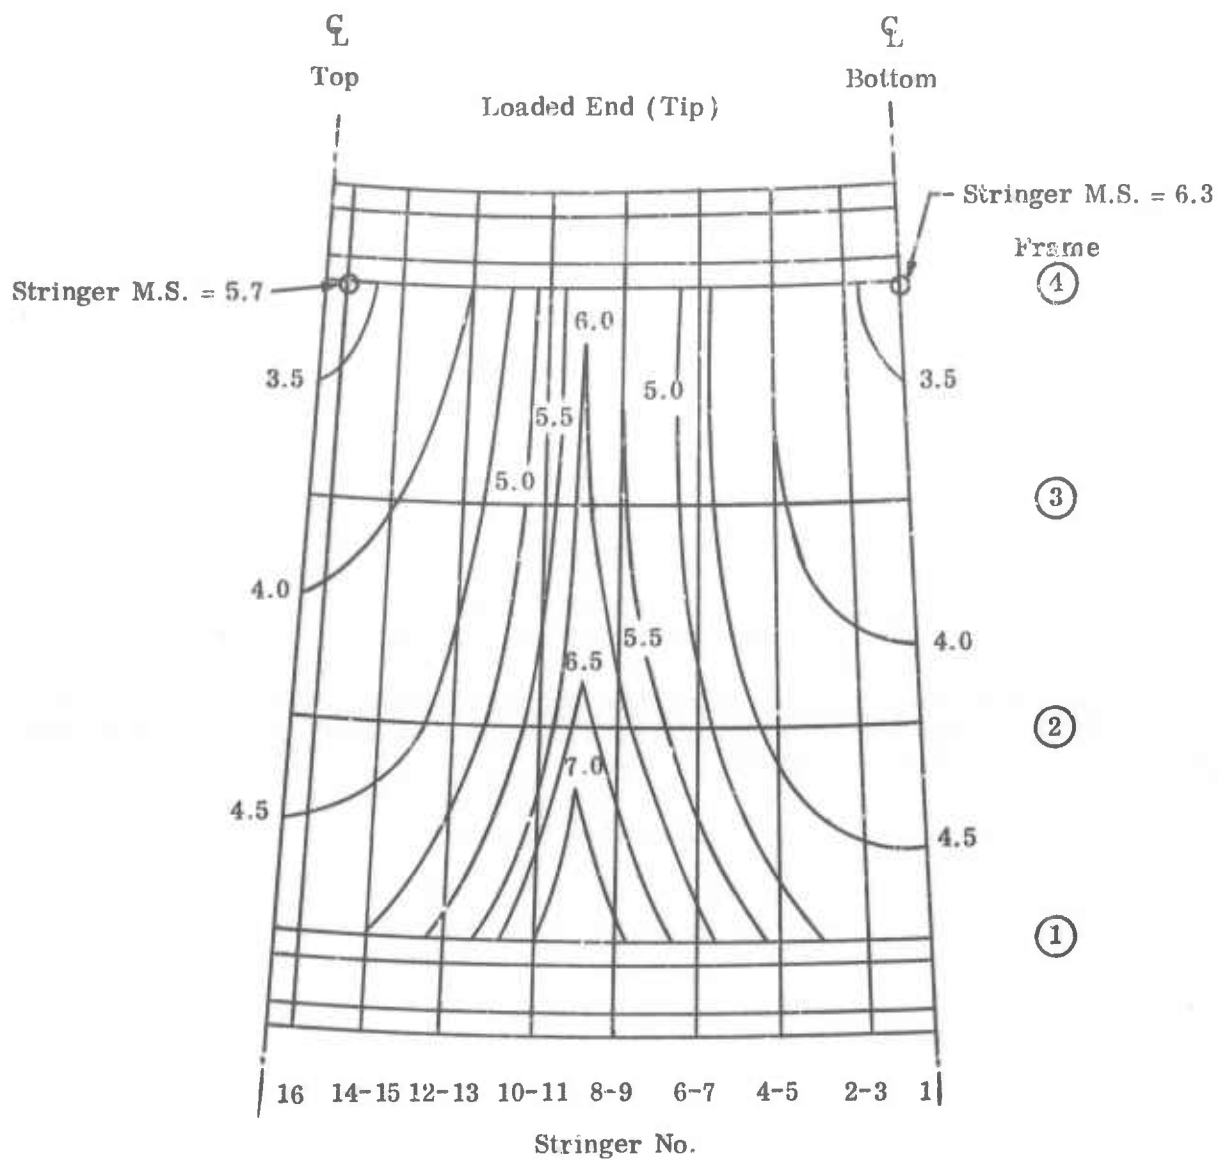
Figure 26. Margin of Safety Distribution (Developed Shell)
Load Condition 3 - Moment and Torque

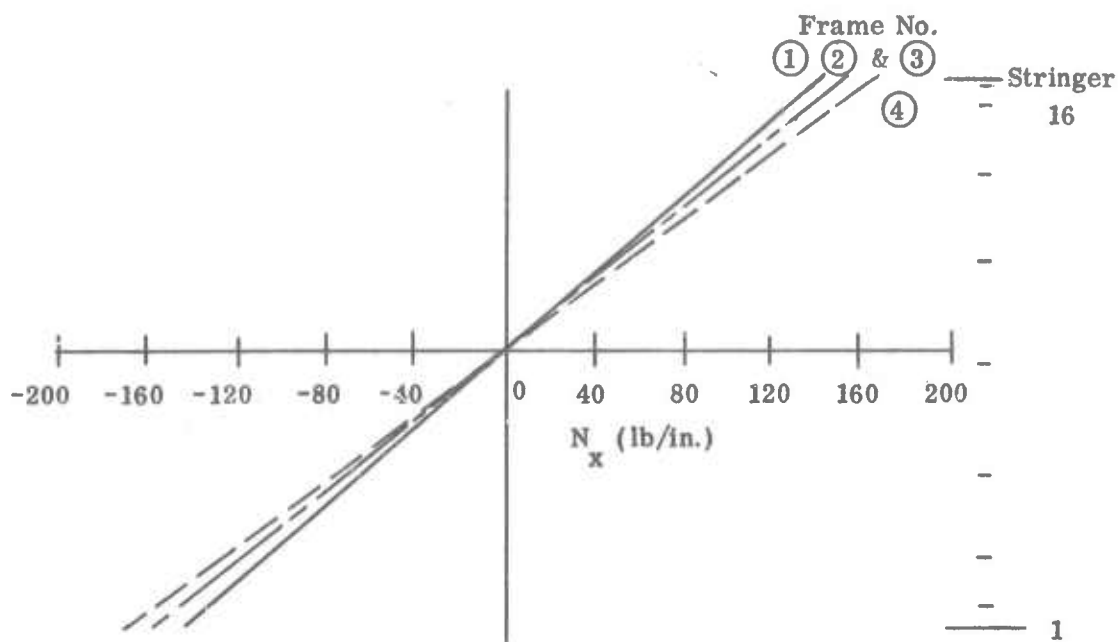
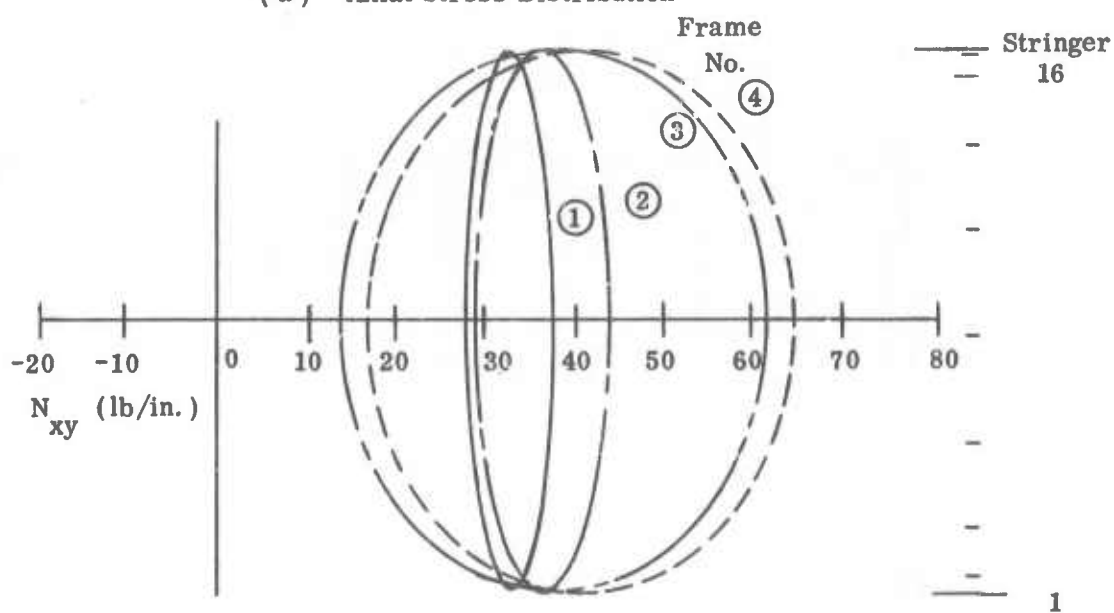
Figure 27. Stress Distribution at Ring Frames of Fuselage Shell - Load Condition 3 (Moment and Torsion)

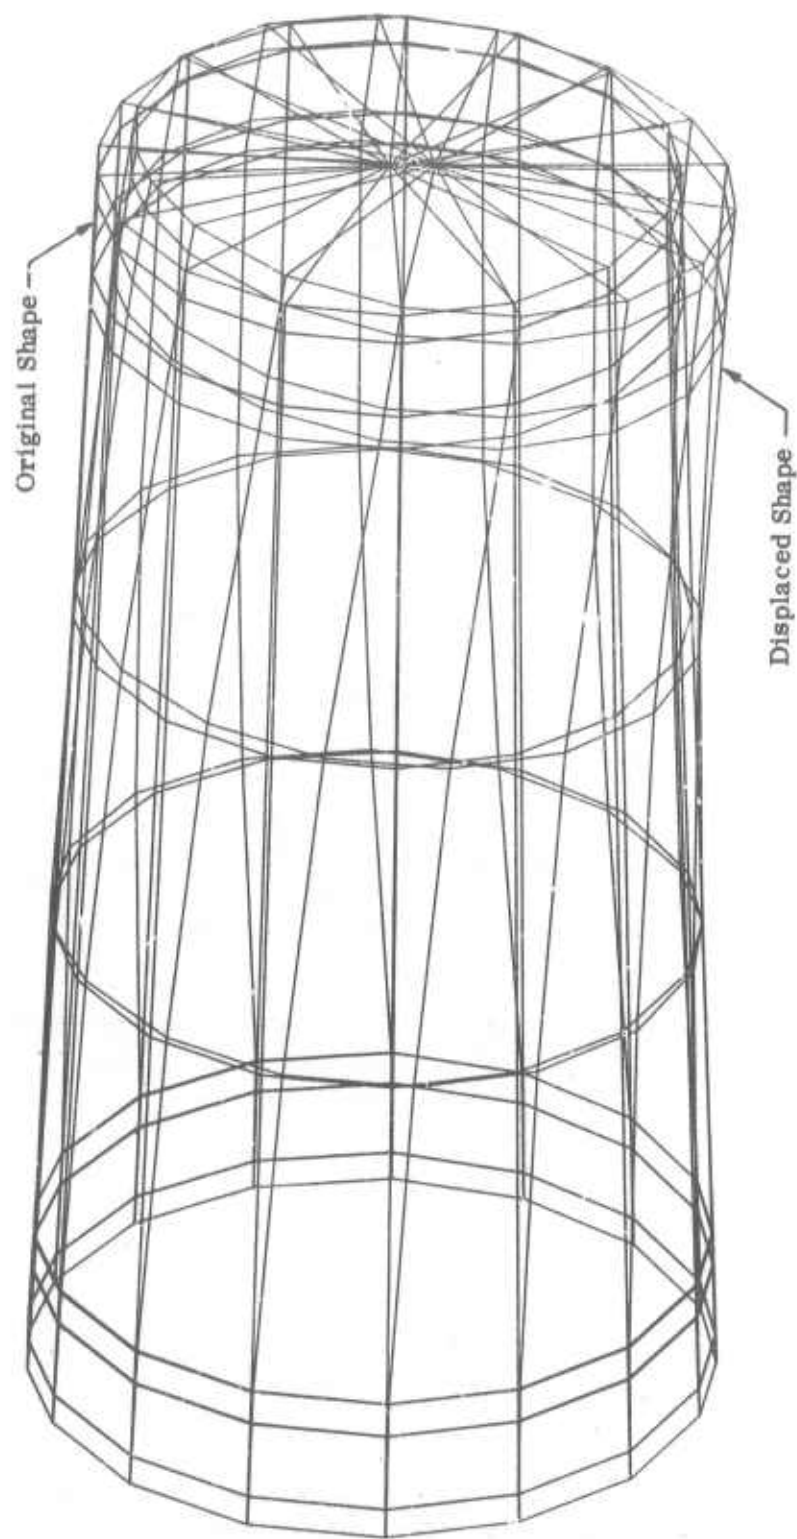
Figure 28. Computer Drawn Displacement Plot for Load Condition 3

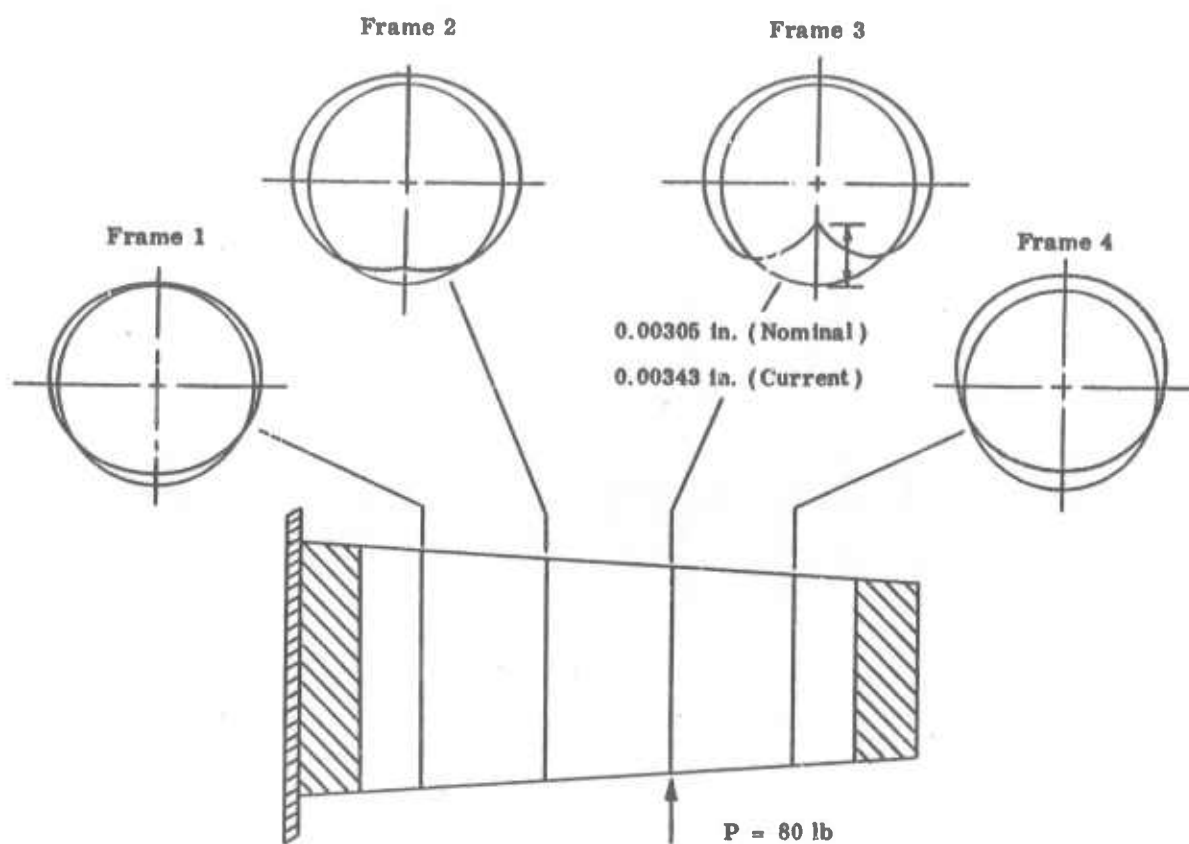
Figure 29. Frame Deflections with Local Applied Load

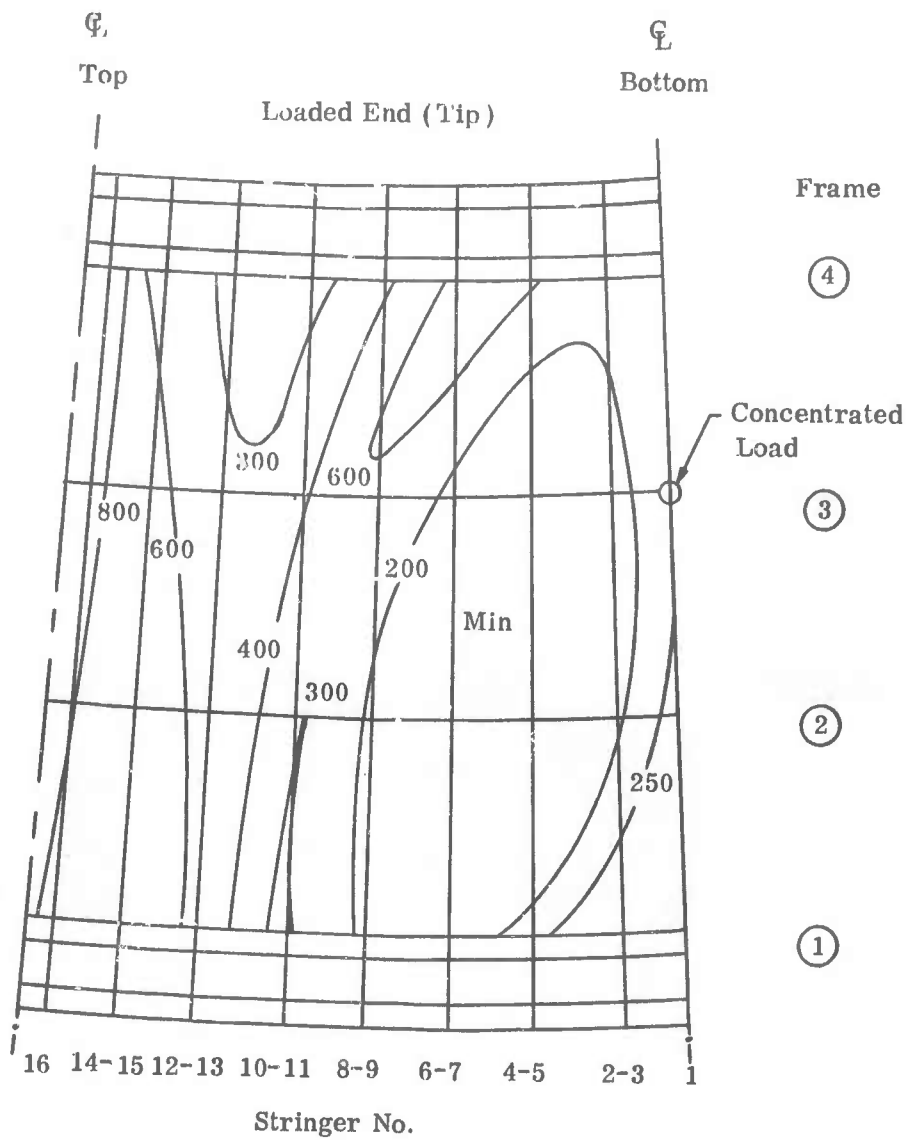
Figure 30. Margin of Safety Distribution (Developed Shell)
Load Condition 4 - Concentrated Load

Figure 30 shows a plot of shell margins of safety for L.C. 4. The margins of safety are large; however, the contours are presented to illustrate the expected pattern. Figure 31 shows a computer plot of the displaced shape of the structure with a large scale-up factor.

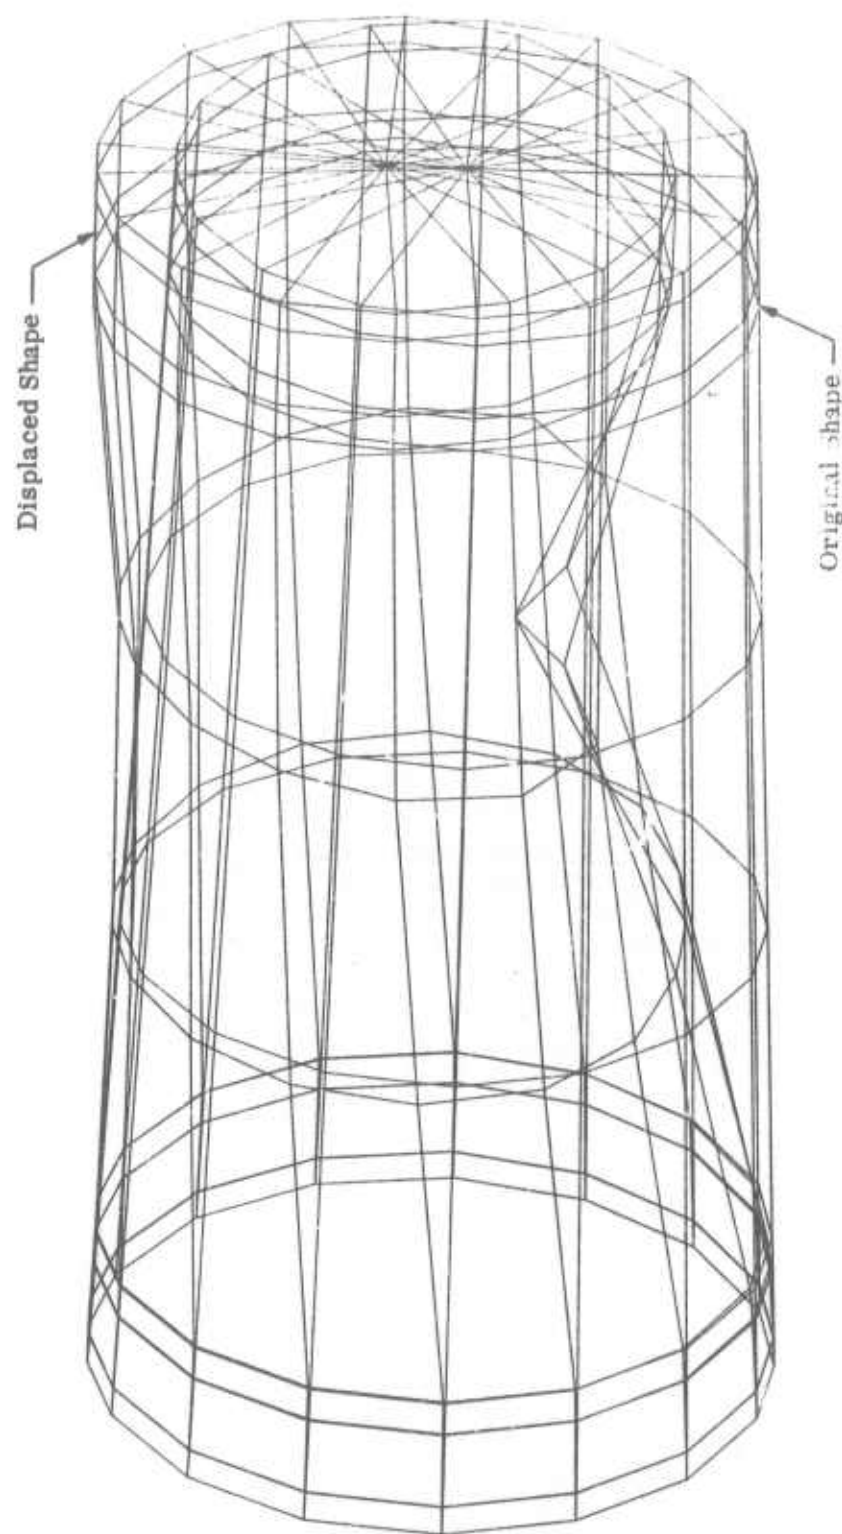
Figure 31. Computer Drawn Displacement Plot for Load Condition 4

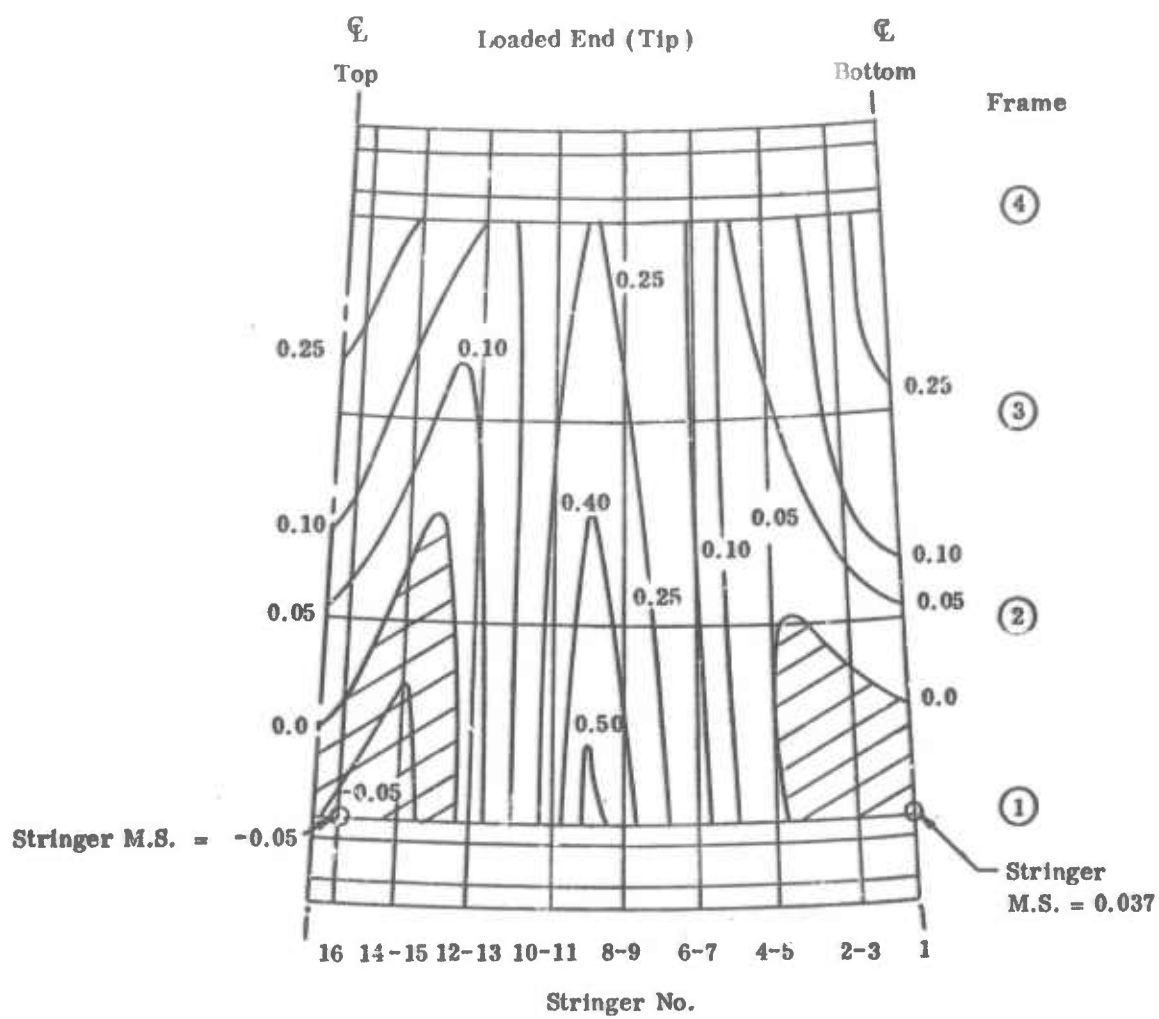
Figure 32. Margin of Safety Distribution (Developed Shell)
Load Condition 5 - Moment and Shear (Ult.)

L.C. 5 was the ultimate load condition tentatively established for the destruct test of the fuselage component. This load condition was subsequently changed as discussed in Section III D. A contour plot of the computed shell margins of safety for the original load condition is given in Figure 32. Comparison with Figure 23 for L.C. 1 shows significant differences. These differences reflect the fact that in L.C. 5 the shear load relative to the bending moment is considerably larger. Thus, in many respects, the M.S. contour plot bears a greater similarity to that for shear loading only as established in the nominal analysis (See Figure 5 of Reference 6) than to Figure 23. As for L.C. 1, the minimum L.C. 5 margins of safety for the upper and lower surfaces occur at the root, the absolute minimum occurring, as expected, on the tension (top) surface due to the slightly lower tension allowable. These margins are negative and are indicated by the hatched regions of Figure 32. However, it should be noted that the lowest margins do not appear at the extreme top and bottom of the structure, but several stringers away from the top and bottom positions. The negative zones are seen also to move further away from the extreme top and bottom, going from the root toward the tip. This action is accounted for by the interaction of shear and bending stresses due to the shell taper and end conditions. Since shear stress is essentially zero at the extreme top and bottom of the structure, the M.S. values there are essentially tension or compression values. However, moving away from the extremities, the shear stress increases, and since the shear allowable is quite low, the combined stress M.S. drops off. In addition, moving from the root to the tip, the bending stresses drop off (See Figure 33 (a)) but, initially, the shear stresses increase (See Figure 33 (b)). Hence the negative margins persist, but tend to shift towards the midpanels where shear stress governs.

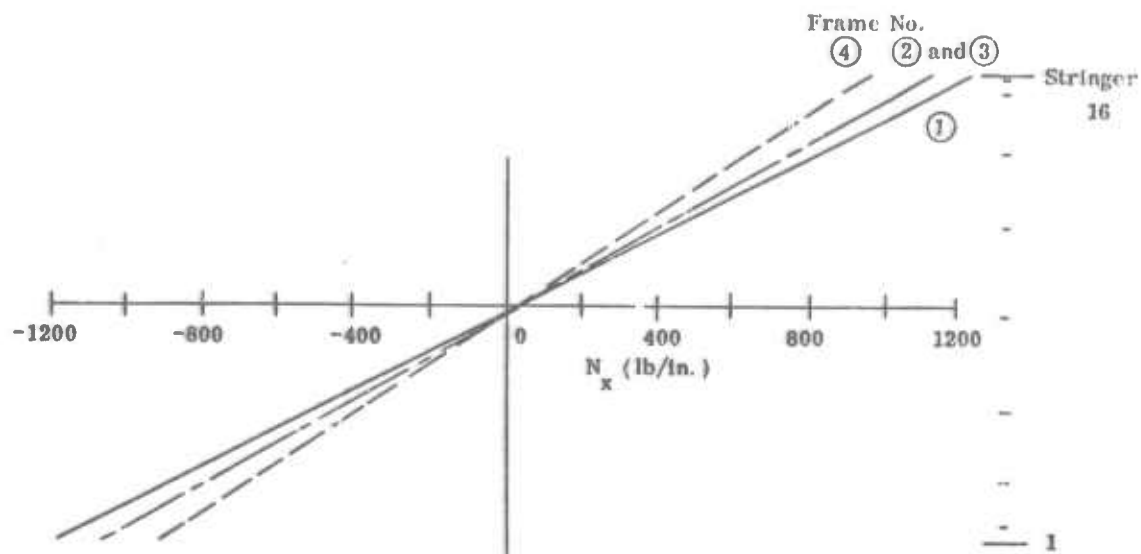
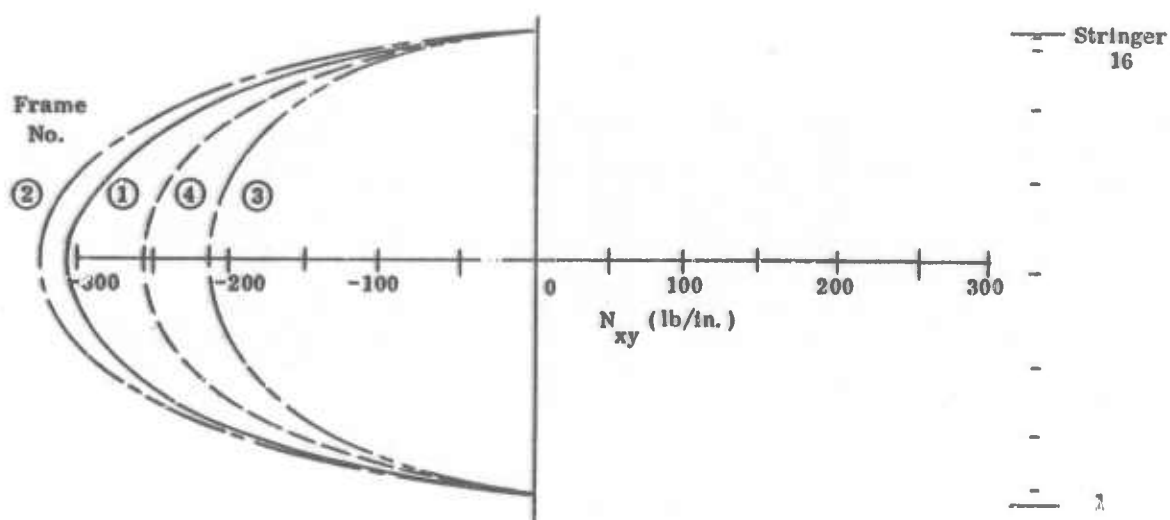
Figure 33. Stress Distribution at Ring Frames-Load Condition 5
Moment and Shear (Ult.)

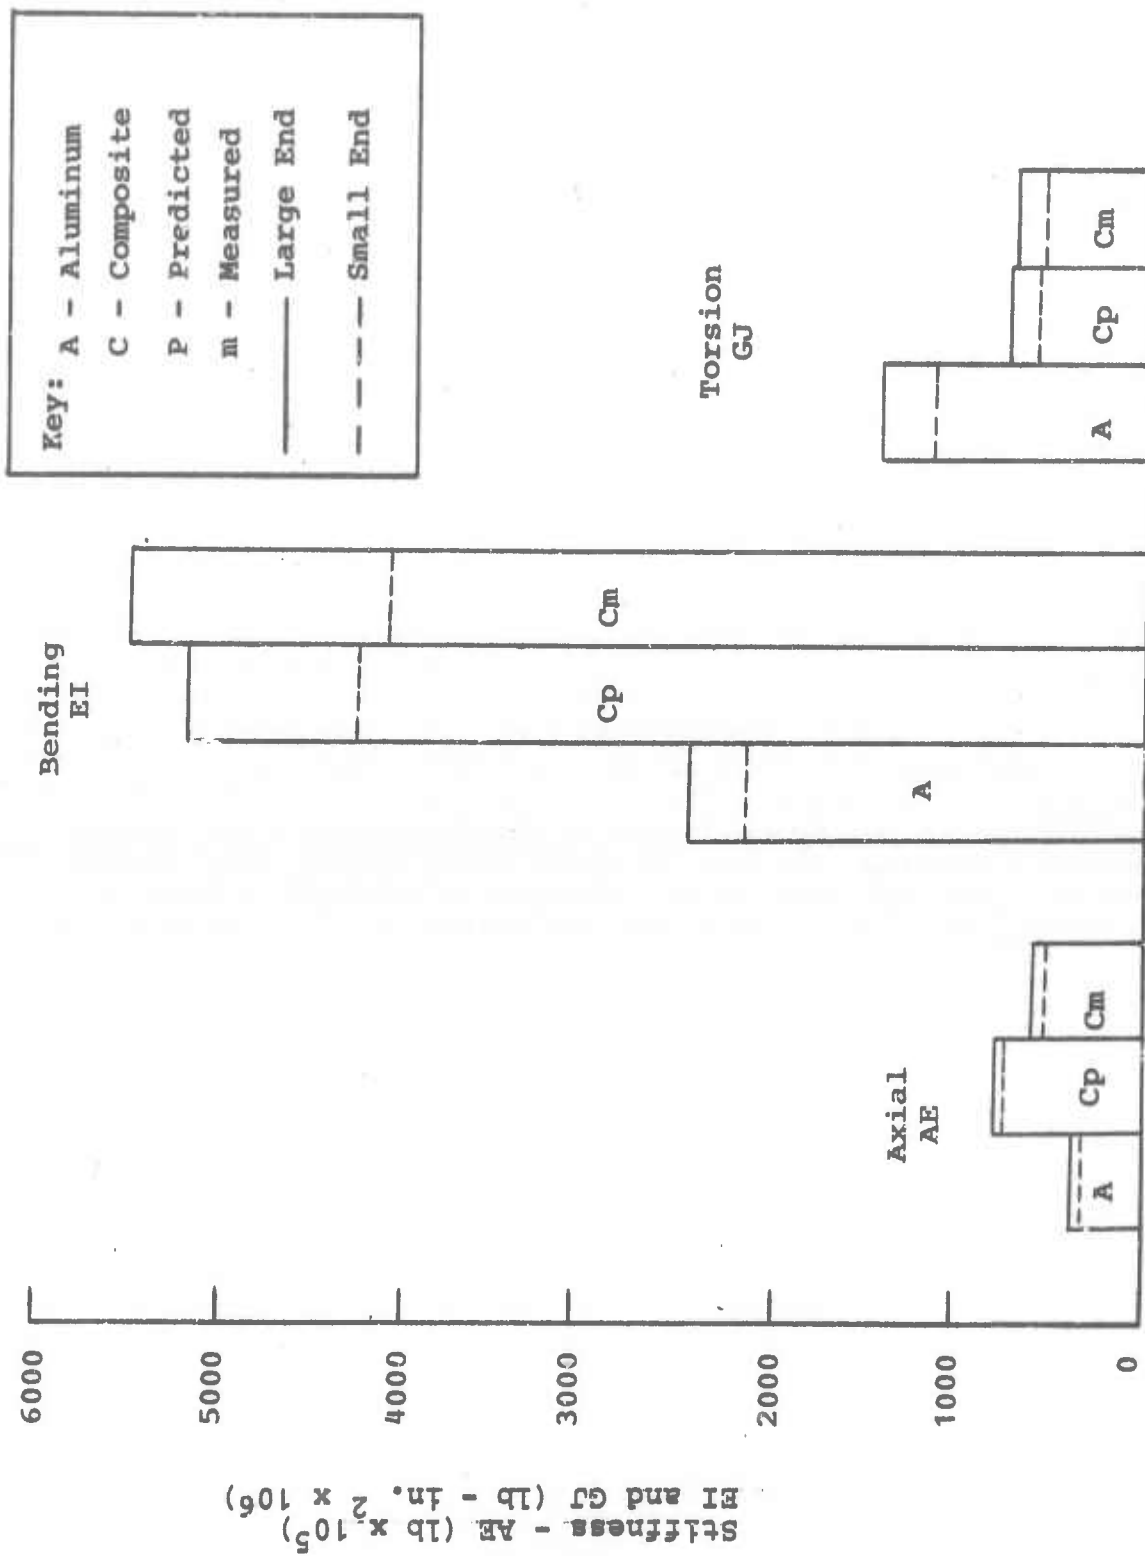
Figure 34. Fuselage Stiffnesses

The composite AE measured about 25% less than predicted. That difference is thought due to the fact that moduli were considered equal in tension and compression and to factors such as thickness variations. The equivalent E for the component was 13 million psi, 30% greater than aluminum. The equivalent G was 1.34 million psi, 12% greater than the minimum 1.2 million psi design requirement. Thus, the composite GJ values shown represent adequate torsional stiffness.

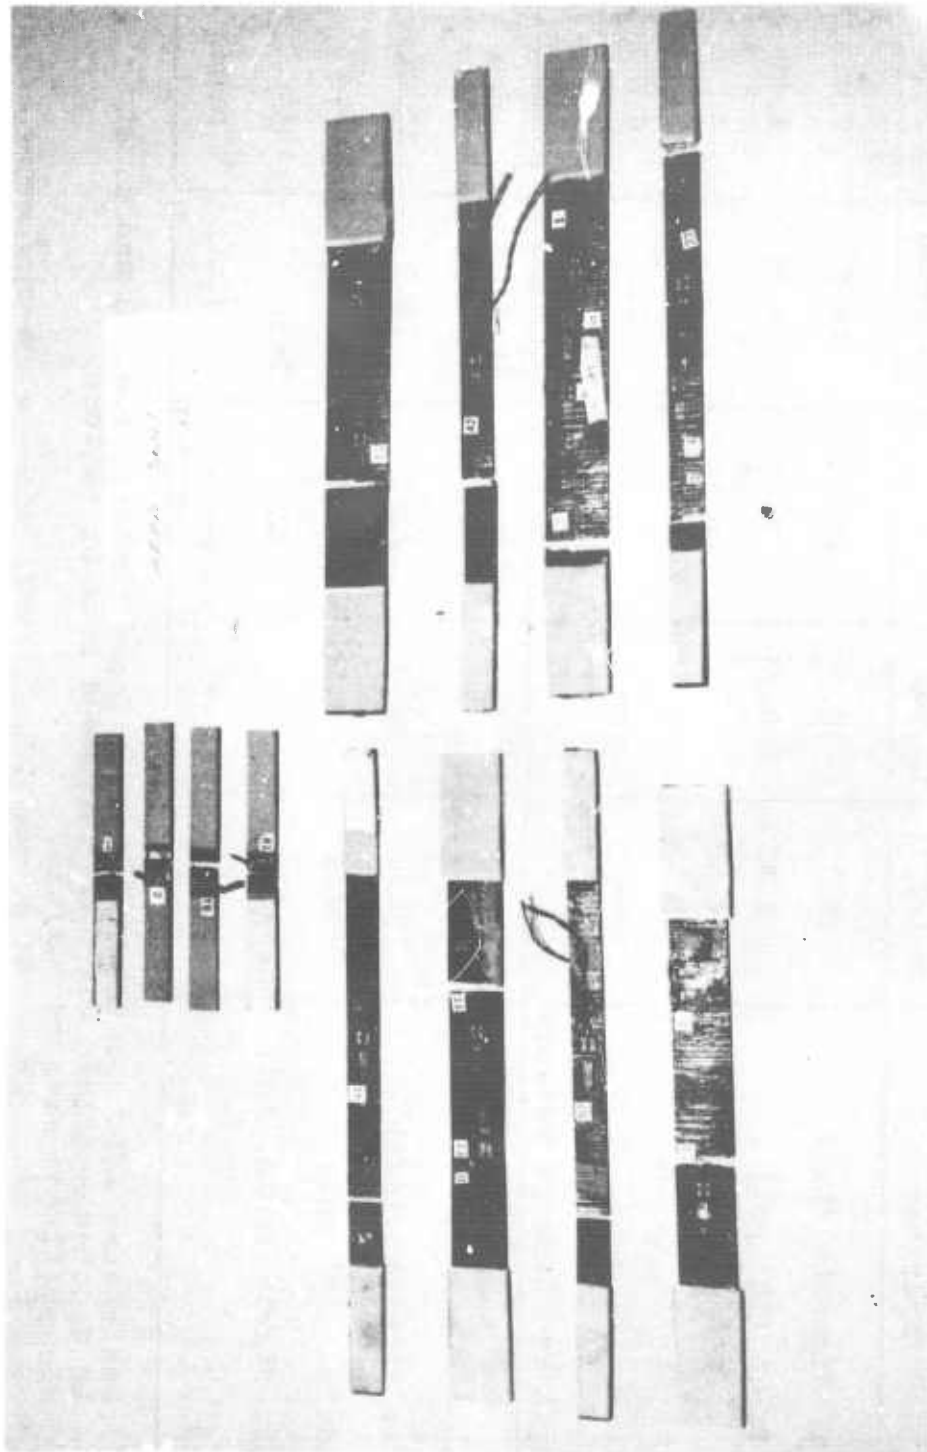
309999 P700070

Figure 36. Failed Tension and Compression Specimens Taken from Fuselage Skin.

Test results are summarized in Table VIII. It is curious to note that the average ultimate strength of specimens taken from the bay toward the large-end side of the failure, denoted LE, were approximately 27% higher than those from the small end (SE) side of the failure. A similar discrepancy was observed in moduli. It may also be noted in Table VIII that the strength and modulus of the treated "Thornel" 50 skin was two to three times that of the practice skin. (Table VII).
